THE CONSERVATION OF OTTOMAN ERA NEIGHBOURHOODS IN ISTANBUL: A
CASE STUDY OF ARNAVUTKOY, BESIKTAS

A Dissertation submitted for

MSc in Architectural Conservation,

University of Edinburgh

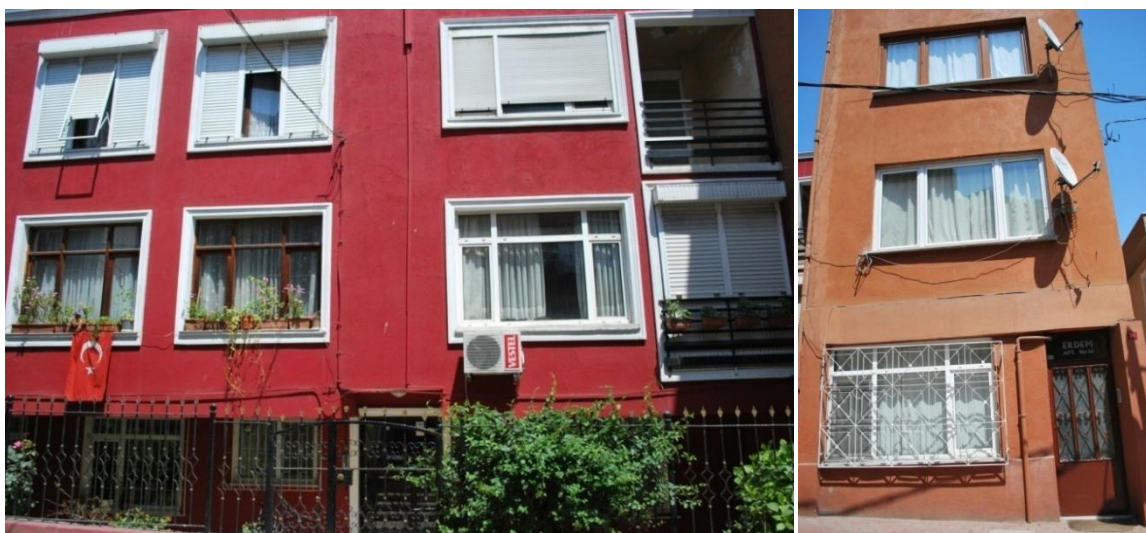
Figure 63: Facades of Later Developments on Kirechane Street

On the parallel street of Beyazgul Street, Kirechane Street, reinforced concrete structures which were built in recent years do not follow the similar facade view as the historic buildings do, as seen in figure 63. The streets in Arnavutköy are narrow, stepped, sloping but the new buildings on the streets have wide facades which contradict with the traditional houses which have narrow, timber clad facades with balconies, bay windows that overshadow streets, as in the figure 64.

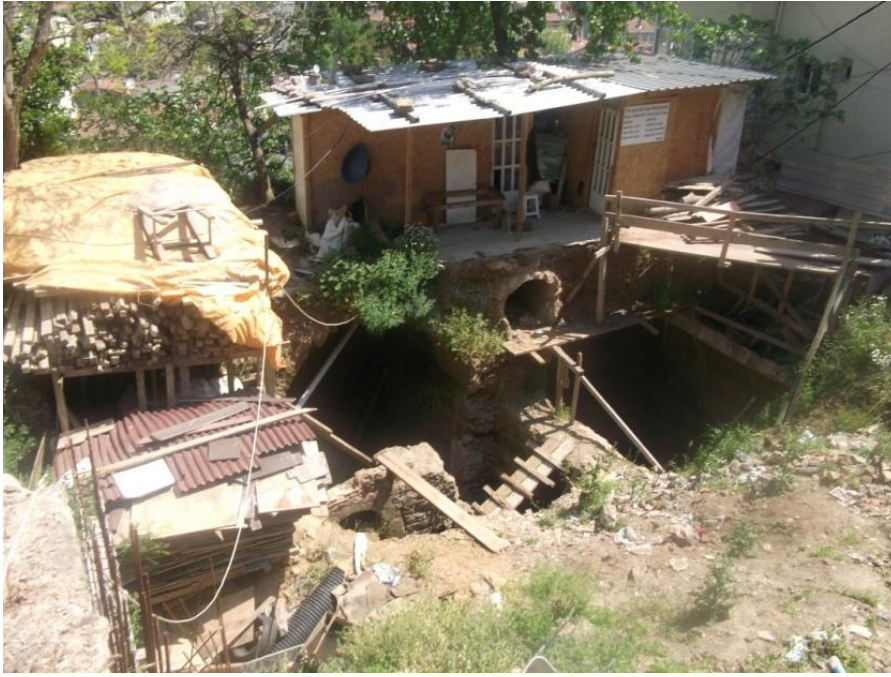
The area is very significant not just with its richly ornamented buildings that date back to Ottoman period but also with its natural landscape; woods, and vaulted ruins both in underground and aboveground levels as seen in figure 67.

Figure 67: Listed Arched Structure and Its Restoration
